1. AGENCY USE ONLY (Leave blank)	2. REPORT DATE 1996	3. REPORT TYPE AND DATES COVERED Final Report		
4. TITLE AND SUBTITLE The Old Hospital Complex (5EP1778) Fort Carson, Colorado		5. FUNDING NUMBERS

13. ABSTRACT (Maximum 200 words) <p>The Old Hospital Complex (5EP1778) at Fort Carson, Colorado, consists of 59 buildings. The Complex was built during World War II and is significant due to its association with the history of the United States. The complex is semi-permanent construction, constructed from the Department of the Army's Series 800 plans. This report documents the complex in accordance with Section 1(g) of the Memorandum of Agreement enacted among the Department of the Army, Headquarters Fort Carson, the Colorado State Historic Preservation Office, and the Advisory Council on Historic Preservation.</p> <p style="text-align: center;">DTIC QUALITY INSPECTED 2</p>

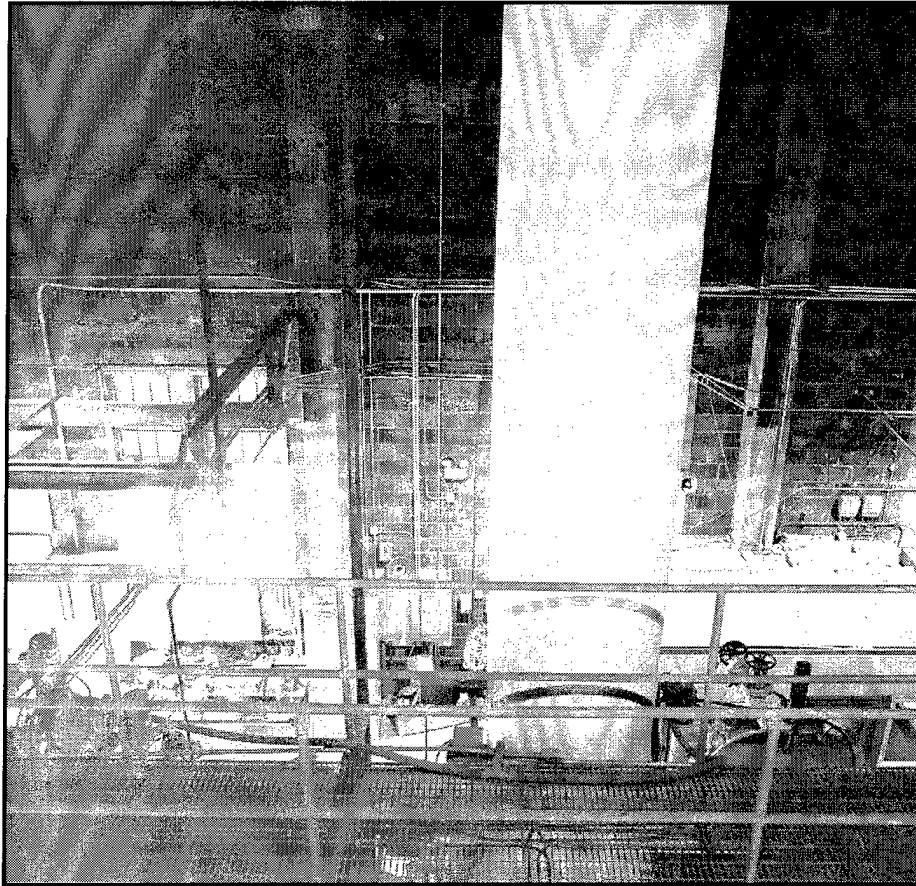
Figure V.286 5EP1778. Building S6290, Steam Plant, 800 Series, Types HSP-8, -9, -10, and -11. Interior shot of machinery and catwalk, viewed from above. Roll 4F, Exposure 2.

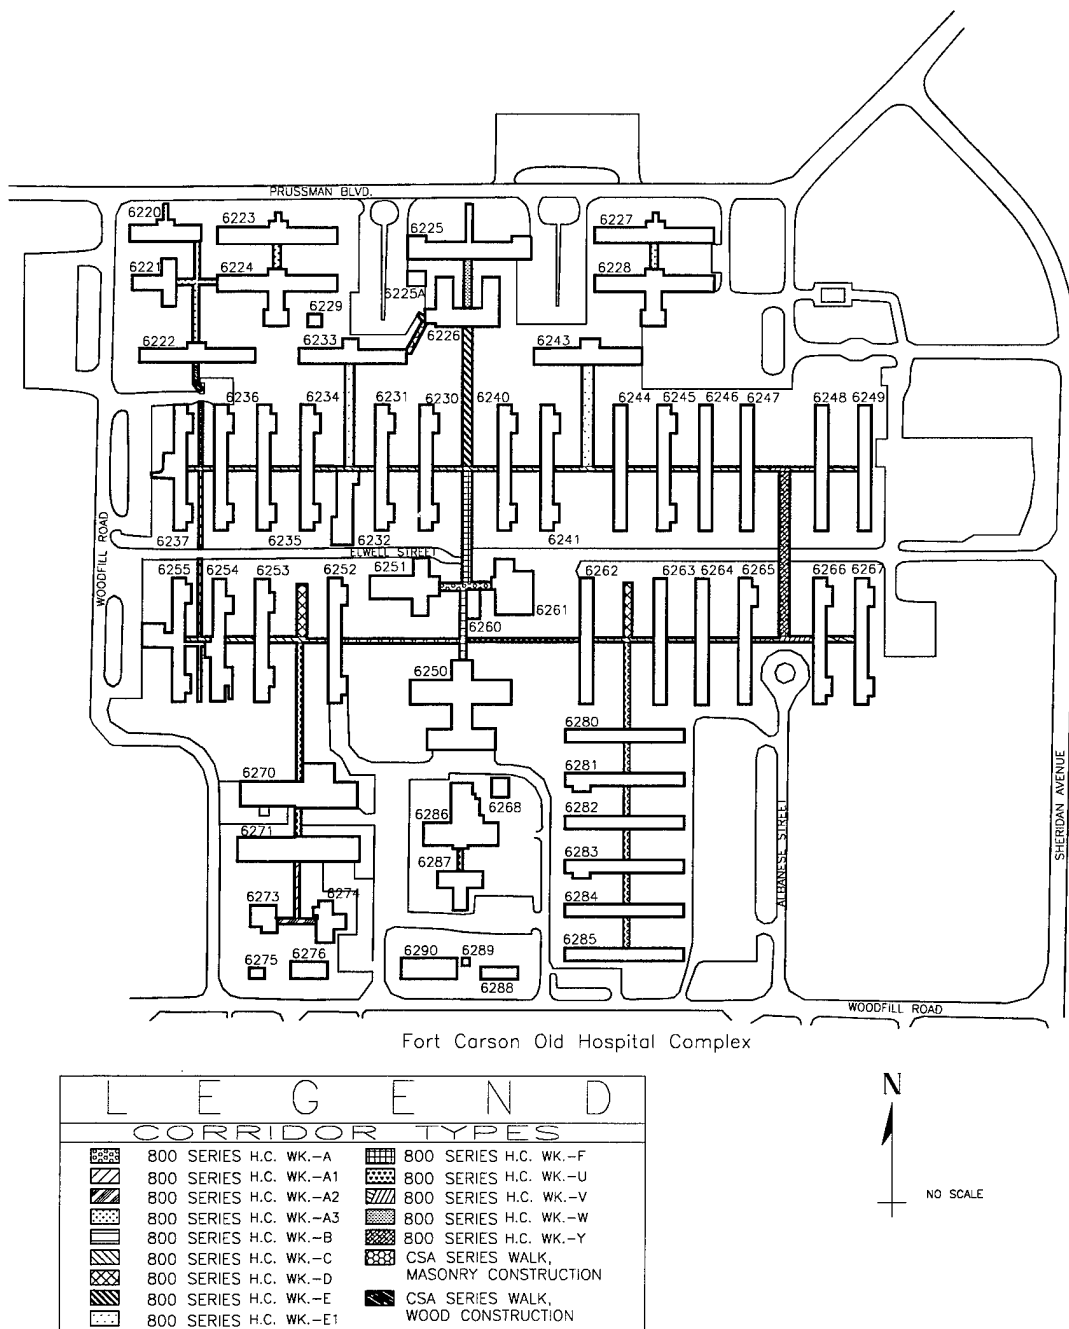
Figure V.287 Location and types of corridors.
